# PHASE I INSPECTION REPORT

## NATIONAL DAM SAFETY PROGRAM

Clifton Forge Dam (Inventory Number  
VA 00503). James River Basin.

Alleghany County, Virginia.  
Phase I Inspection Report.

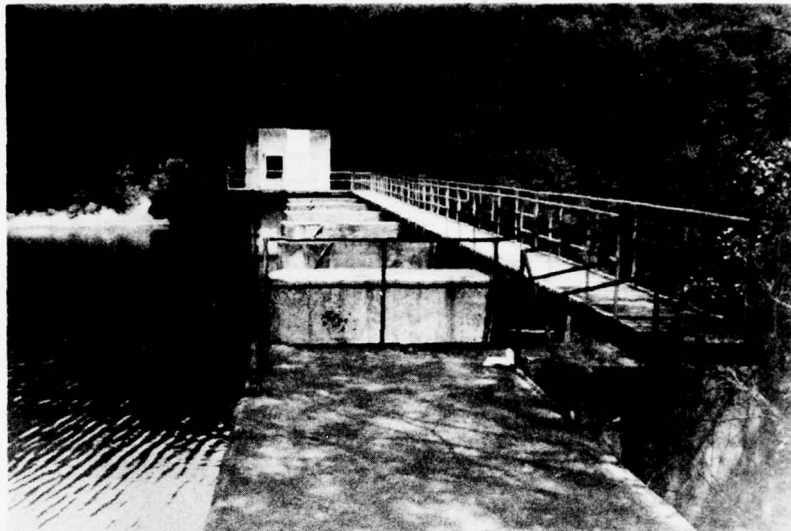
VIEW OF DAM FROM RIGHT ABUTMENT

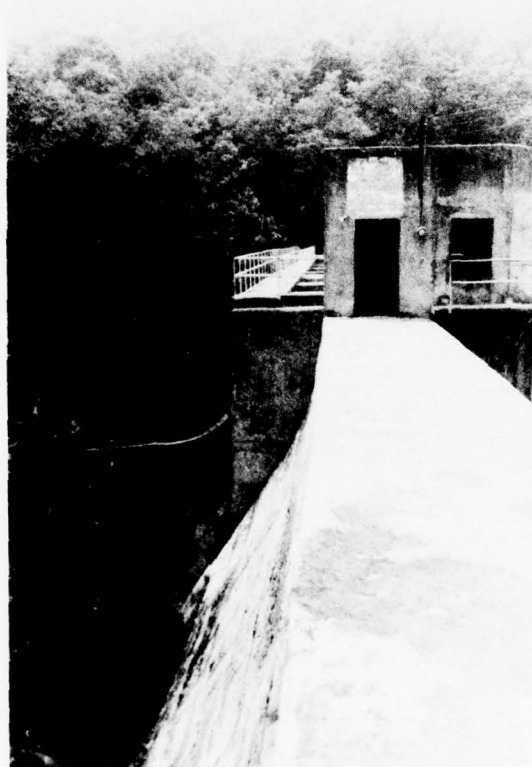
VIEW OF DAM FROM LEFT  
ABUTMENT

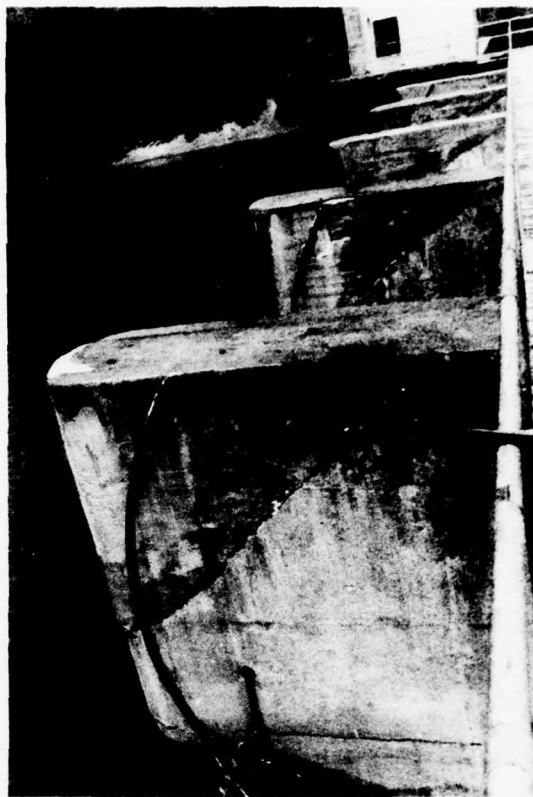
SPILLWAY GATE PIERS

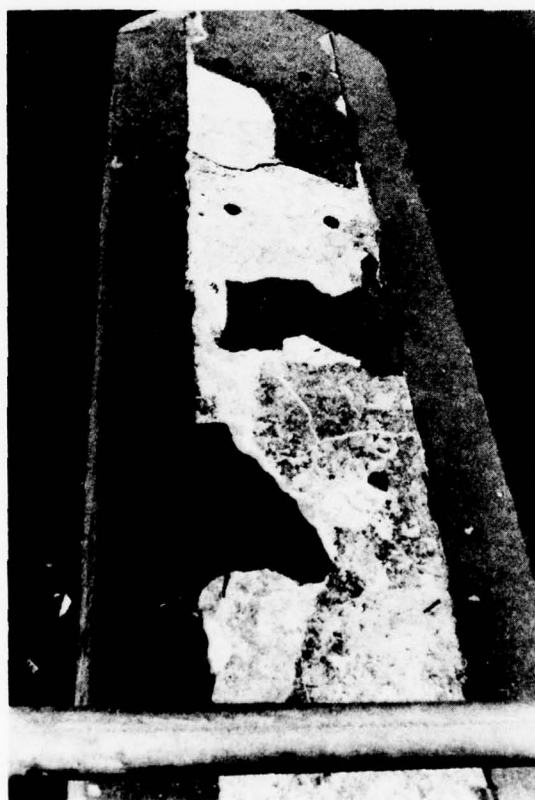
There were no conditions observed which indicated that the dam needed immediate repair. The concrete was scaling in some areas, particularly at the top of the spillway gate piers. For the most part, this scaling appeared to be a mortar-cemented surface which was beginning to separate from the mass concrete beneath. More severe scaling is occurring on the face of the dam near the left abutment. The scaling is occurring at a horizontal joint at the top surface of a lift of concrete.

The cause of the scaling is unknown but it could be due to "freeze-thaw" action on the surface, brought about by seepage through the construction joint. The scaling concrete is several inches deep and runs along the entire length of the bulkhead section of the dam, 23 feet below the top. The scaling does not appear to represent a condition which would affect the safety of the dam, but the owner should consider repairing it as part of a general maintenance procedure.

SCALING CONCRETE ON THE TOP  
OF THE SPILLWAY PIERS

concrete debris from the old 12-inch downstream pipeline and repair of the scaling concrete, should be done. It is also suggested that future consideration be given to increasing the spillway capacity.

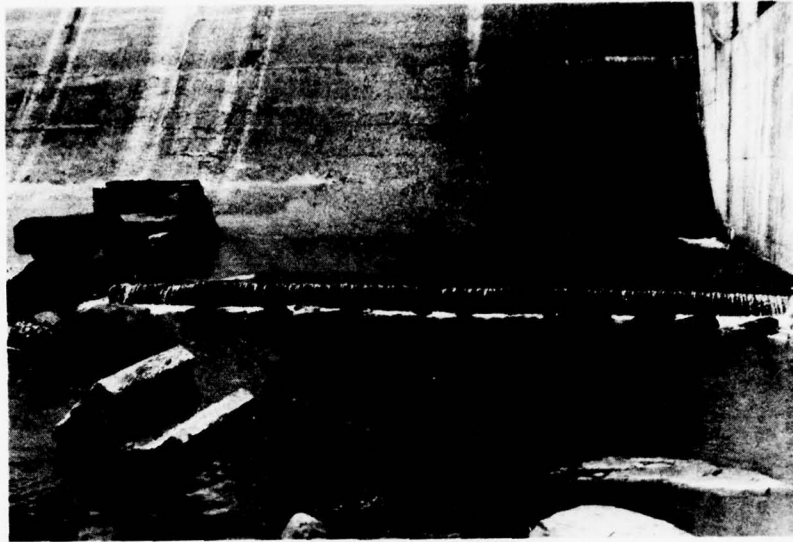
A large discharge over the dam in 1950 caused the existing scour at the end of the spillway. The old 12-inch pipeline, in existence prior to the construction of the dam, was washed out and the streambed was heavily scoured. However, there was no evidence of a deep scour pool at the end of the spillway. Another large flood was produced by Hurricane Camille in 1969. A damage survey of Smith Creek was performed by the Corps of Engineers in 1971 after the flood and no serious damage to the dam was noted in their report. A portion of the report is included in Appendix IV.

BASE OF SPILLWAY CHUTE - RESERVOIR OUTLET IS ON  
RIGHT, SOME DAMAGE RESULTING FROM HURRICANE CAMILLE ON LEFT?

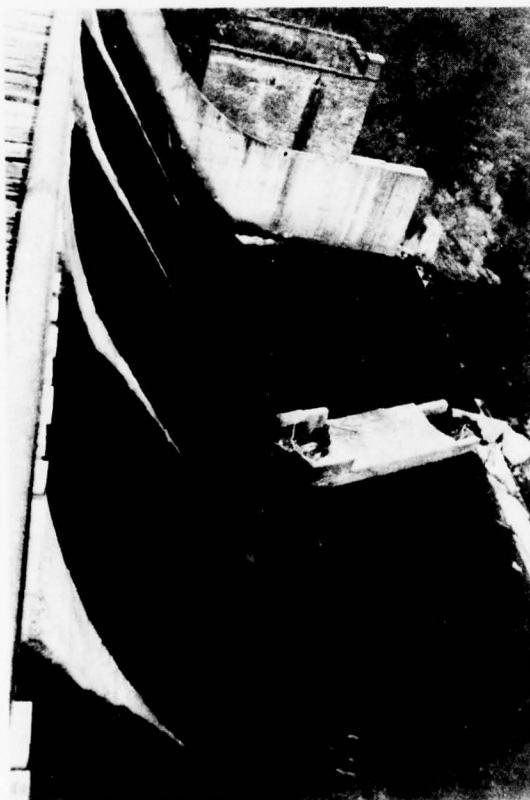
SPILLWAY CHUTE FROM TOP  
OF DAM
